Nevada
Environmental
Restoration
Project

Post-Closure Inspection Report for
the Tonopah Test Range, Nevada

For Calendar Year 2004

U.S. Department of Energy
National Nuclear Security Administration
Nevada Site Office

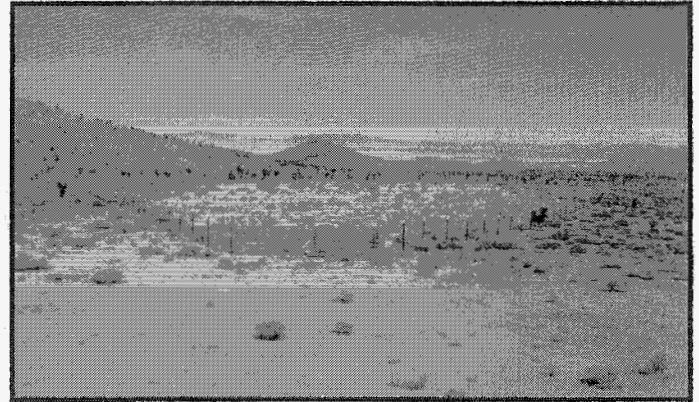
Inside fence, looking east, June 2000
